Technical Report M3

**SIDE CHANNEL SEDIMENTATION STUDY OF THE  
MISSISSIPPI RIVER  
MARQUETTE CHUTE/CAPE BEND  
RIVER MILES 51 TO 47**

**HYDRAULIC MICRO MODEL INVESTIGATION**

December 1997

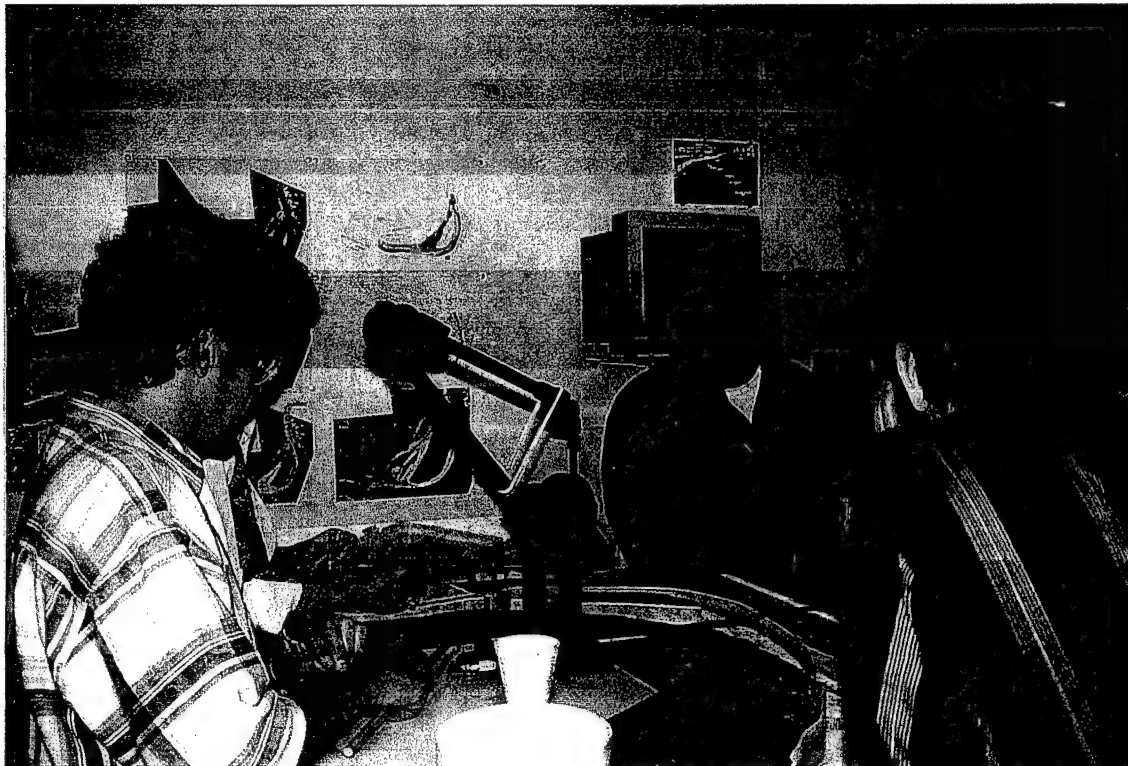
U.S. ARMY ENGINEER DISTRICT, ST. LOUIS CORPS OF ENGINEERS ST. LOUIS, MISSOURI
PREPARED BY R. TETRICK CHECKED BY R. DAWSON DATE 4 AUGUST 1997	MARQUETTE CHUTE MICRO-MODEL STUDY MISSISSIPPI RIVER MILES 47.0 - 53.0 Photograph of Engineers and Biologists Formulating Ideas on the Marquette Chute Micro Model
	PLATE NO 1

A team of cooperating federal and state agencies assembled at the U.S. Army Corps of Engineers Applied River Engineering Center (AREC) in St. Louis, Missouri to formulate and conceptualize measures to enhance and/or restore the side channel at Marquette Island (Plate 1). A variety of environmental design alternatives were submitted. The main goal was to evaluate the positive impacts of these alternatives, if any, on the resultant bed configuration (sediment transport response) and flow patterns within the Mississippi River study reach. Creating desirable biological diversity while at the same time ensuring a reliable navigation channel was the major challenge of this study.

Finally, it should be noted that the innovative ideas set forth in this study were developed as a result of a cooperative effort between all of the aforementioned agencies. "Hands on" experimentation at the Applied River Engineering Center (Plate 1) enabled both biologists and engineers to formulate design alternatives and conduct experiments in the micro model.

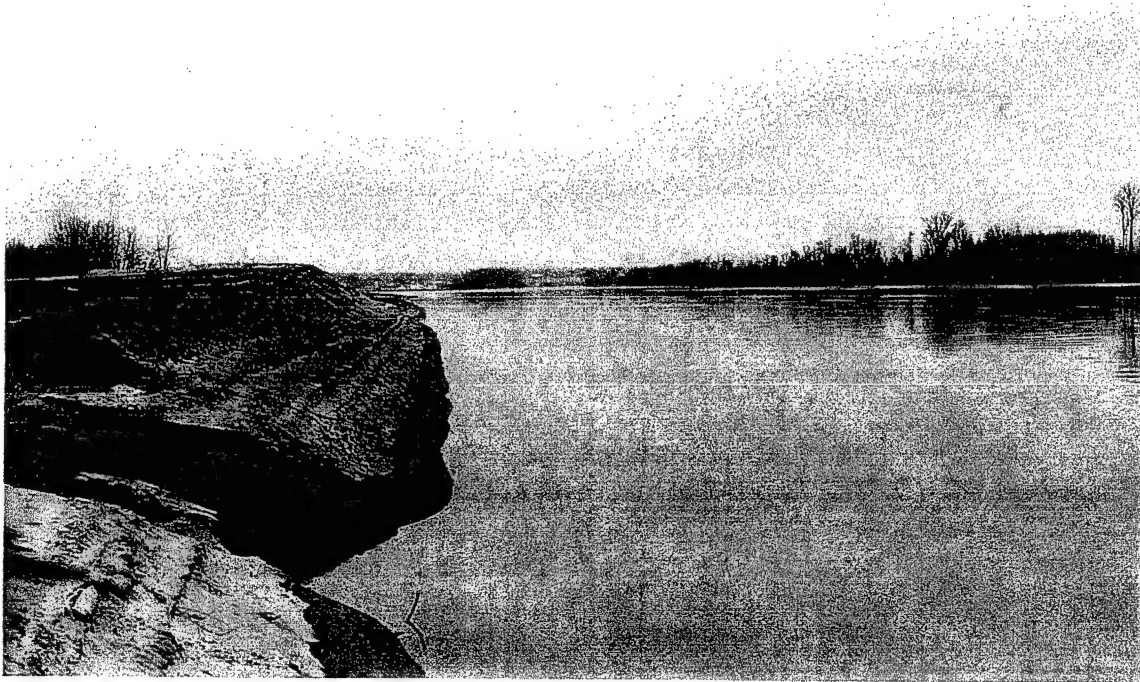
Photograph of Marquette Chute

A site inspection was performed by Robert Hetrick in January of 1997. Photos were taken and are shown in Plates 6 and 7. The river stage at Cape Girardeau was approximately 20.7 which was slightly above mid-bank. Plates 8, 9, and 10 show aerial photographs that were taken by LTRM personnel on May 1<sup>st</sup> when the river stage at Cape Girardeau was approximately 2 feet above flood stage. It is important to note the relatively large area and amount of sediment that was still above the water surface.

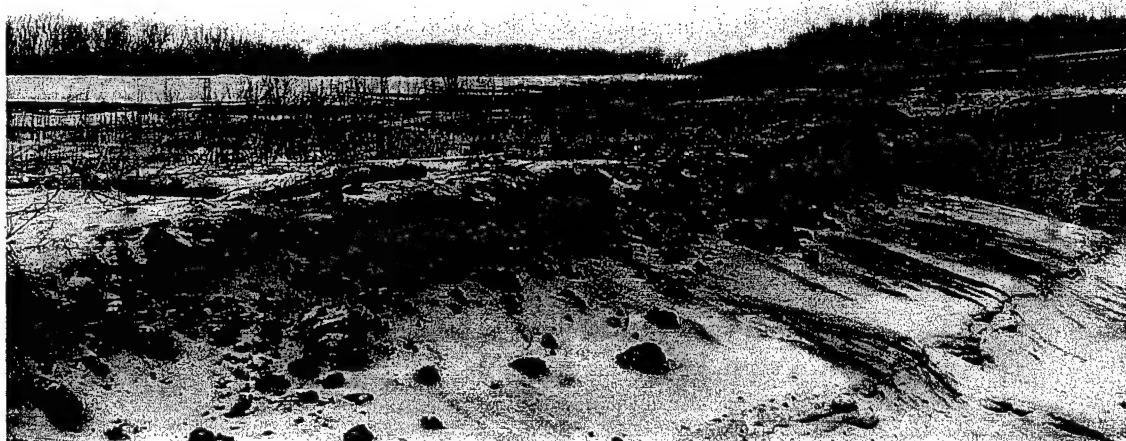
7

Photograph of Marquette Chute

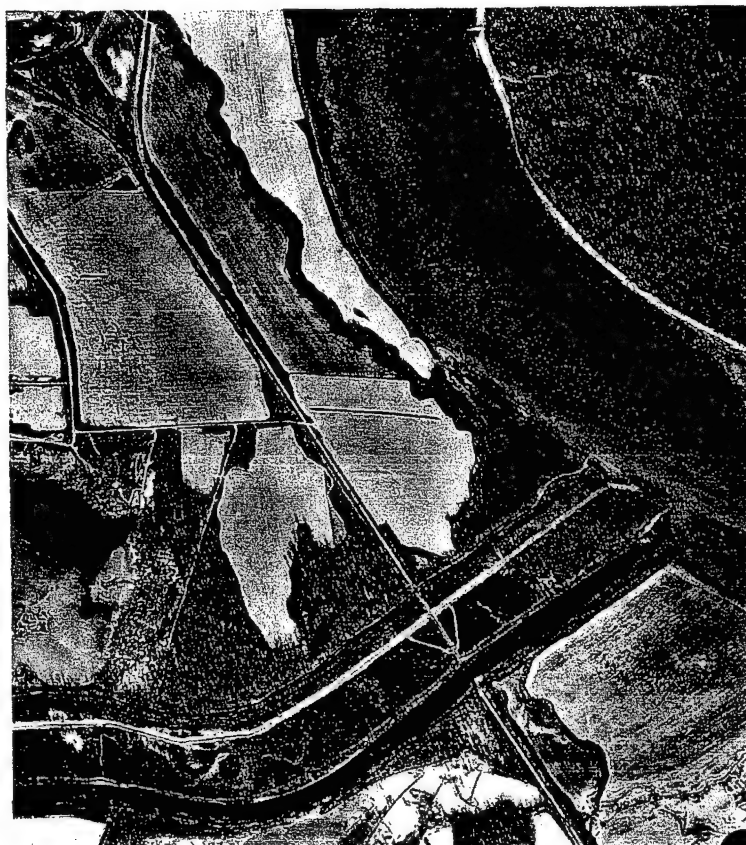
U.S. ARMY ENGINEER DISTRICT, ST. LOUIS CORPS OF ENGINEERS ST. LOUIS, MISSOURI	
PREPARED BY: R. HETPICK CHECKED BY: R. DAVENPORT DATE: 4 AUGUST 1997	MARQUETTE CHUTE MICRO-MODEL STUDY MISSISSIPPI RIVER MILES 47.0 - 53.0  Ice Photograph of Cape Bend	
		12

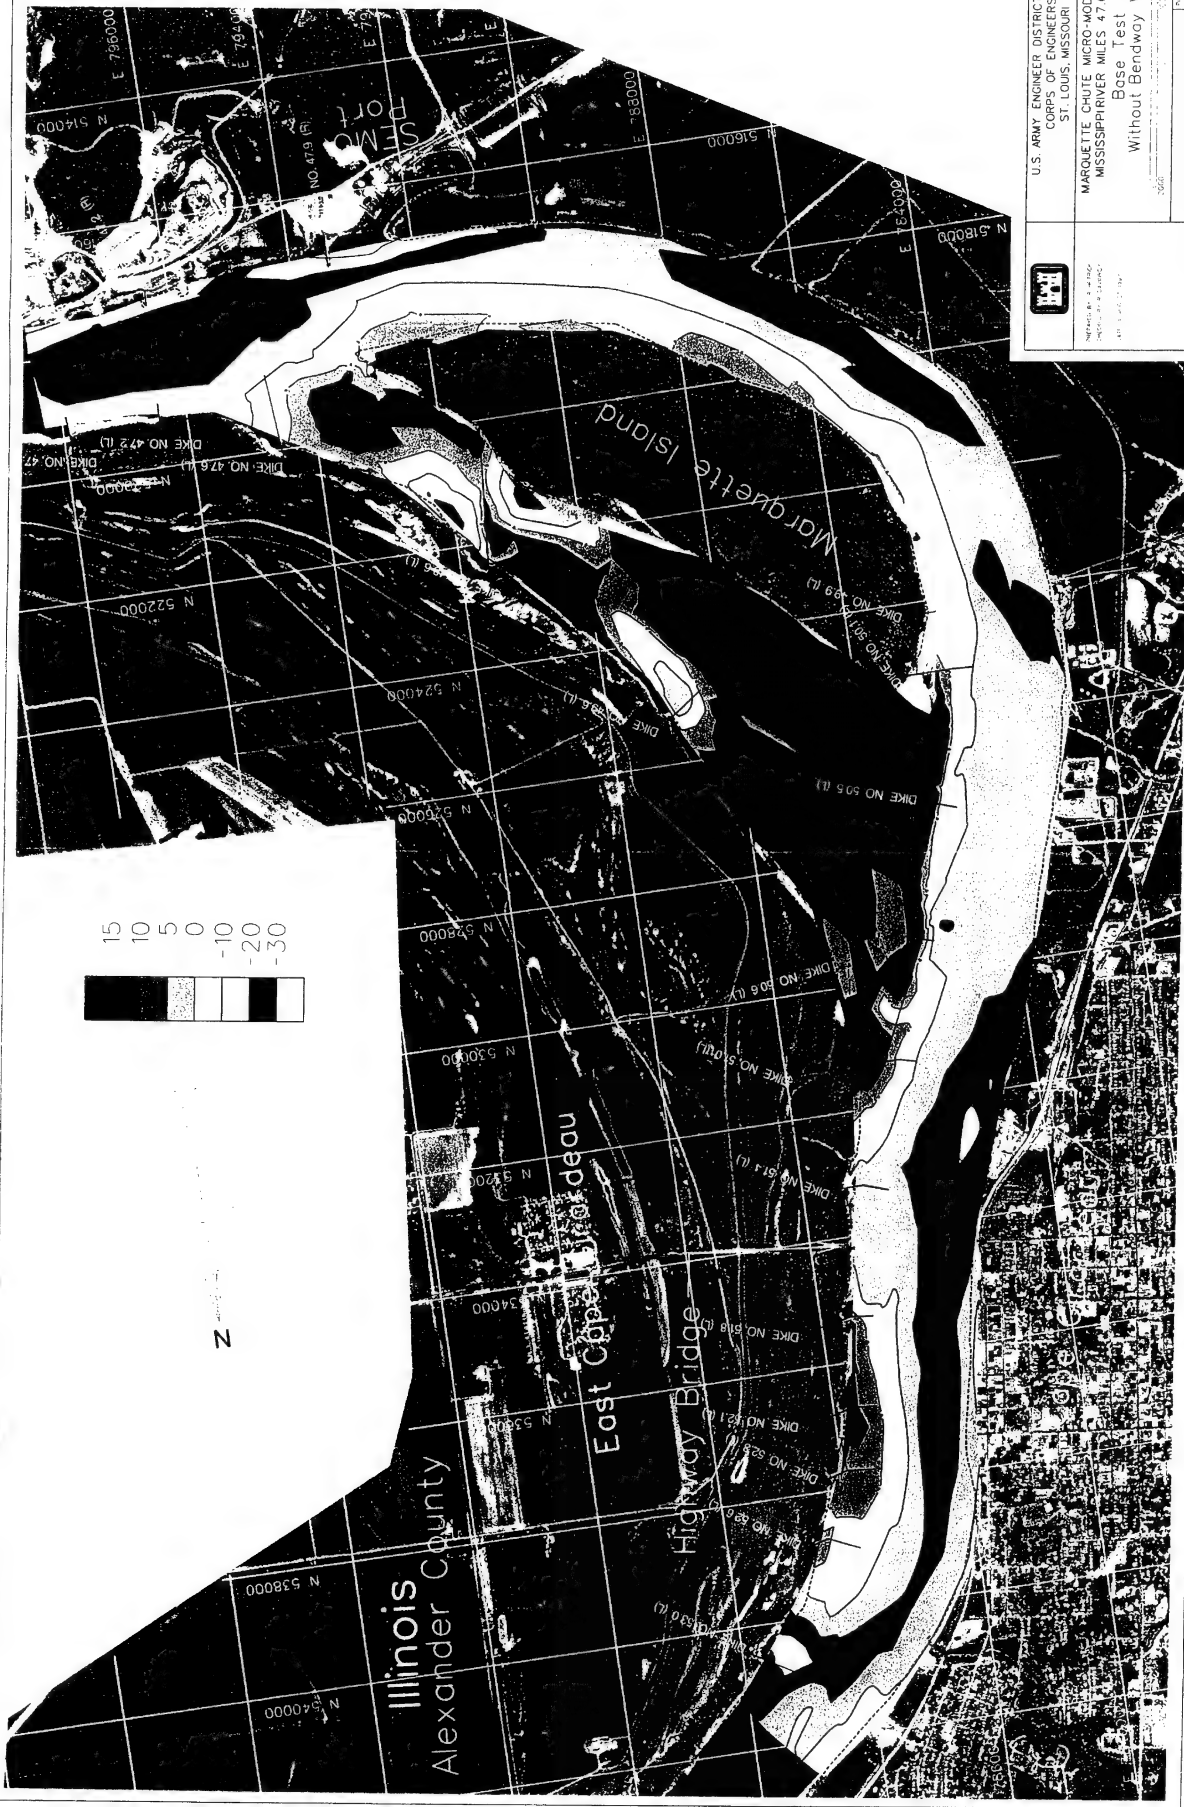
Plate 14 shows the resultant bed survey of the base test without the bendway weirs. In the beginning of the study reach, the thalweg developed off the left descending bank. A scour hole was observed below dike 53.0(L). A crossing developed from

approximately river mile 52.8 to 52.1. The thalweg remained off the right descending bank throughout the rest of the study reach. Scour was also present near mile 51.4 on the right bank and below the apex of the bend near the diversion channel at mile 48.9. The last major area of scour observed in the model occurred off the tip of dike 47.9(R), just below SEMO port. A bar developed on the left descending bank from mile 52.8 to 51.8. A second bar developed at mile 51.3, outside the upper closure structure of Marquette Chute and continued downstream to the end of Marquette Island.

The model also showed very similar trends in the chute as compared to the prototype. There was a small scour hole inside the upper end of the upper closure structure near the existing notch. The deep section of the chute followed the Illinois side of the chute downstream toward the existing hardpoint. A scour hole was observed at this dike. Along the upper end of Marquette Island, a very high bar developed. This bar was vegetated in the prototype. Below the existing hardpoint, the "channel" crossed to the island side of the chute. There was a deep scour hole below the lower closure structure. Below the scour hole, there was a bar that extended through the remainder of the chute toward the confluence with the main channel. The only area in the model that did not accurately reflect the prototype was the area just above the lower closure structure. In the model, there was a large scour hole that formed that was not evident in the prototype. However, this scour hole remained constant throughout all tests. It is believed that this anomaly did not significantly effect the results of any of the tests.

U.S. ARMY ENGINEER DISTRICT ST. LOUIS CORPS OF ENGINEERS ST. LOUIS, MISSOURI
	MARQUETTE CHUTE MICRO-MODEL STUDY MISSISSIPPI RIVER MILES 47.0 - 53.0 Base Test Weirs Without Bendway Weirs
PROJ. NAME: 11-30000-11 PROJ. DATE: 10-1-1961	SHEET NO. 14

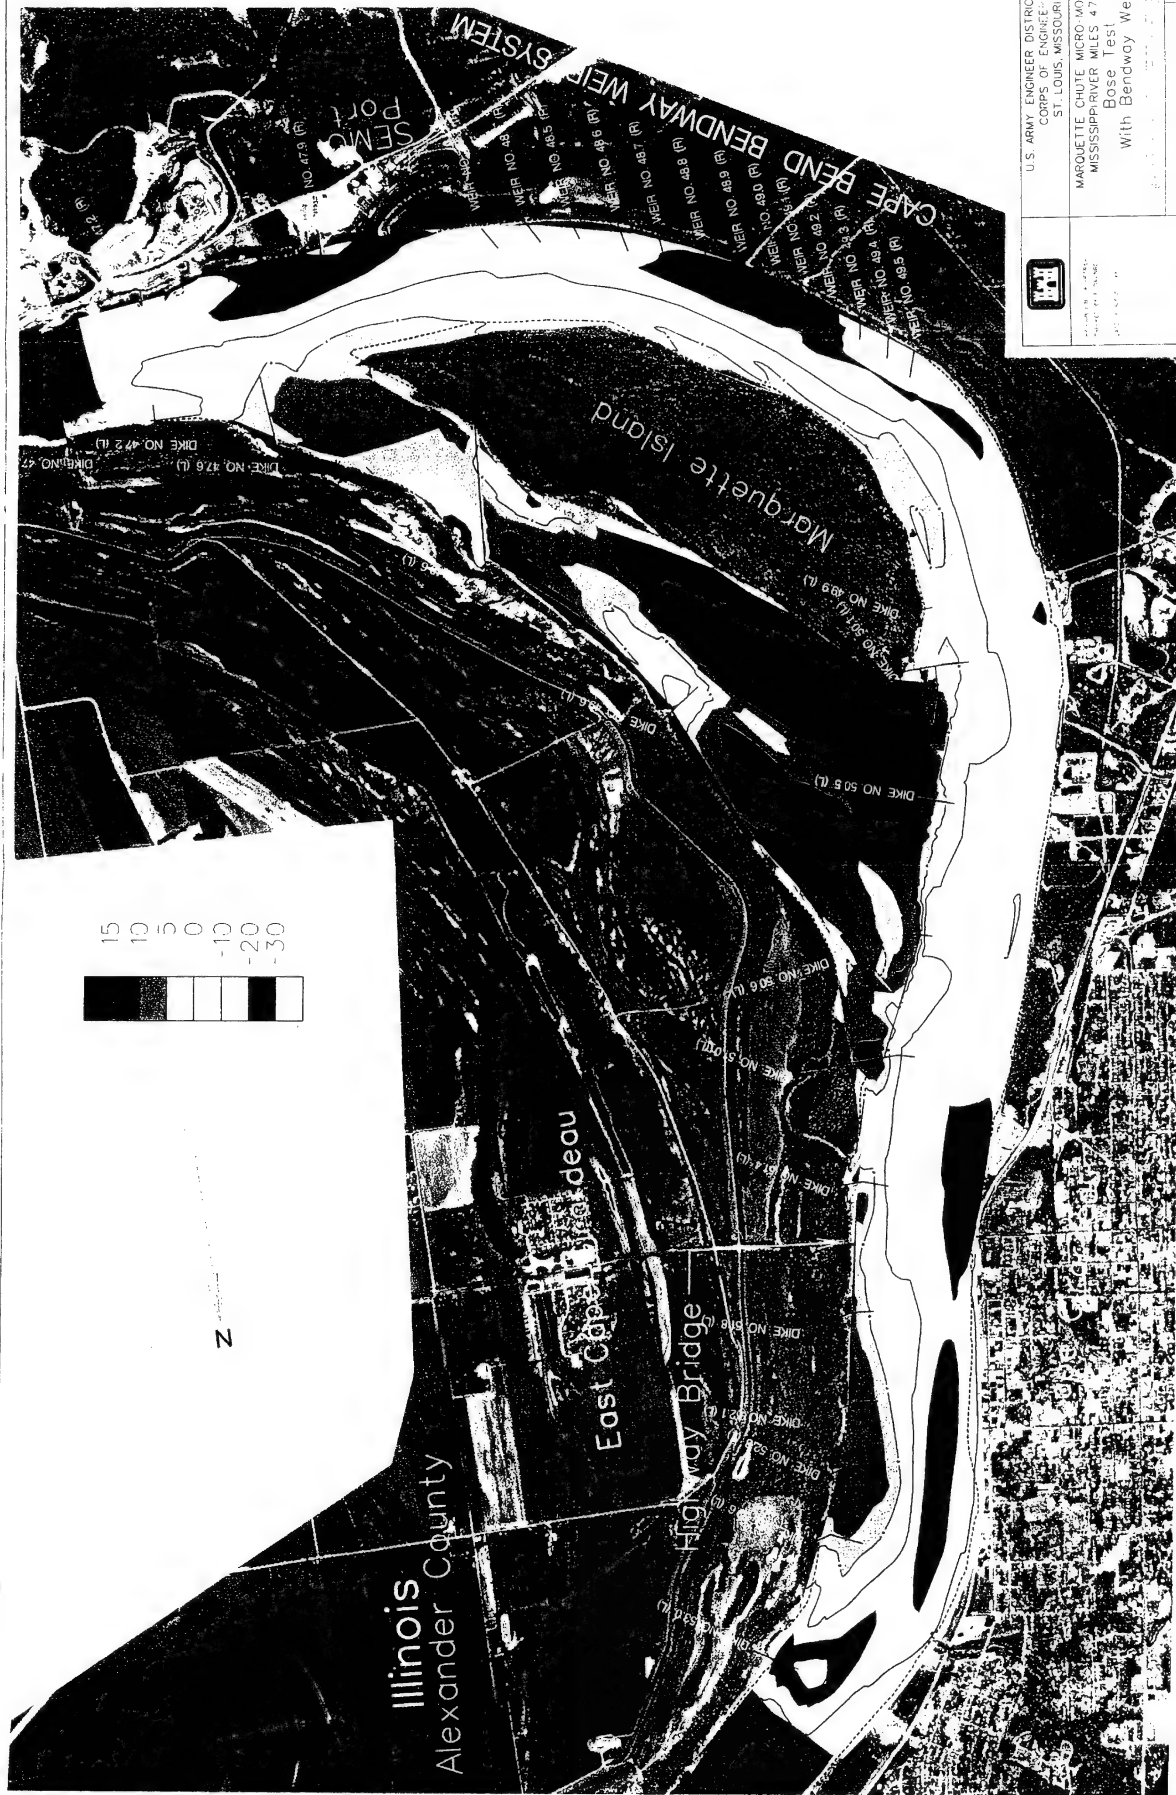
Plate 15 shows the resultant bed survey of the base test with the Bendway Weirfield added. As with the original base test, the model displayed favorable results when compared with the prototype data. The side channel showed no significant changes as compared the original base test. In addition, the main channel showed no significant changes with the exception of the bendway weirfield. In this area, the right bank appeared to have caught additional sediment. The point bar also receded approximately 75 feet when compared to the base test without the weirs.

MARQUETTE CHUTE MICRO MODEL STUDY  
MISSISSIPPI RIVER MILES 470 - 530  
Bose Test  
With Bendway Weirs

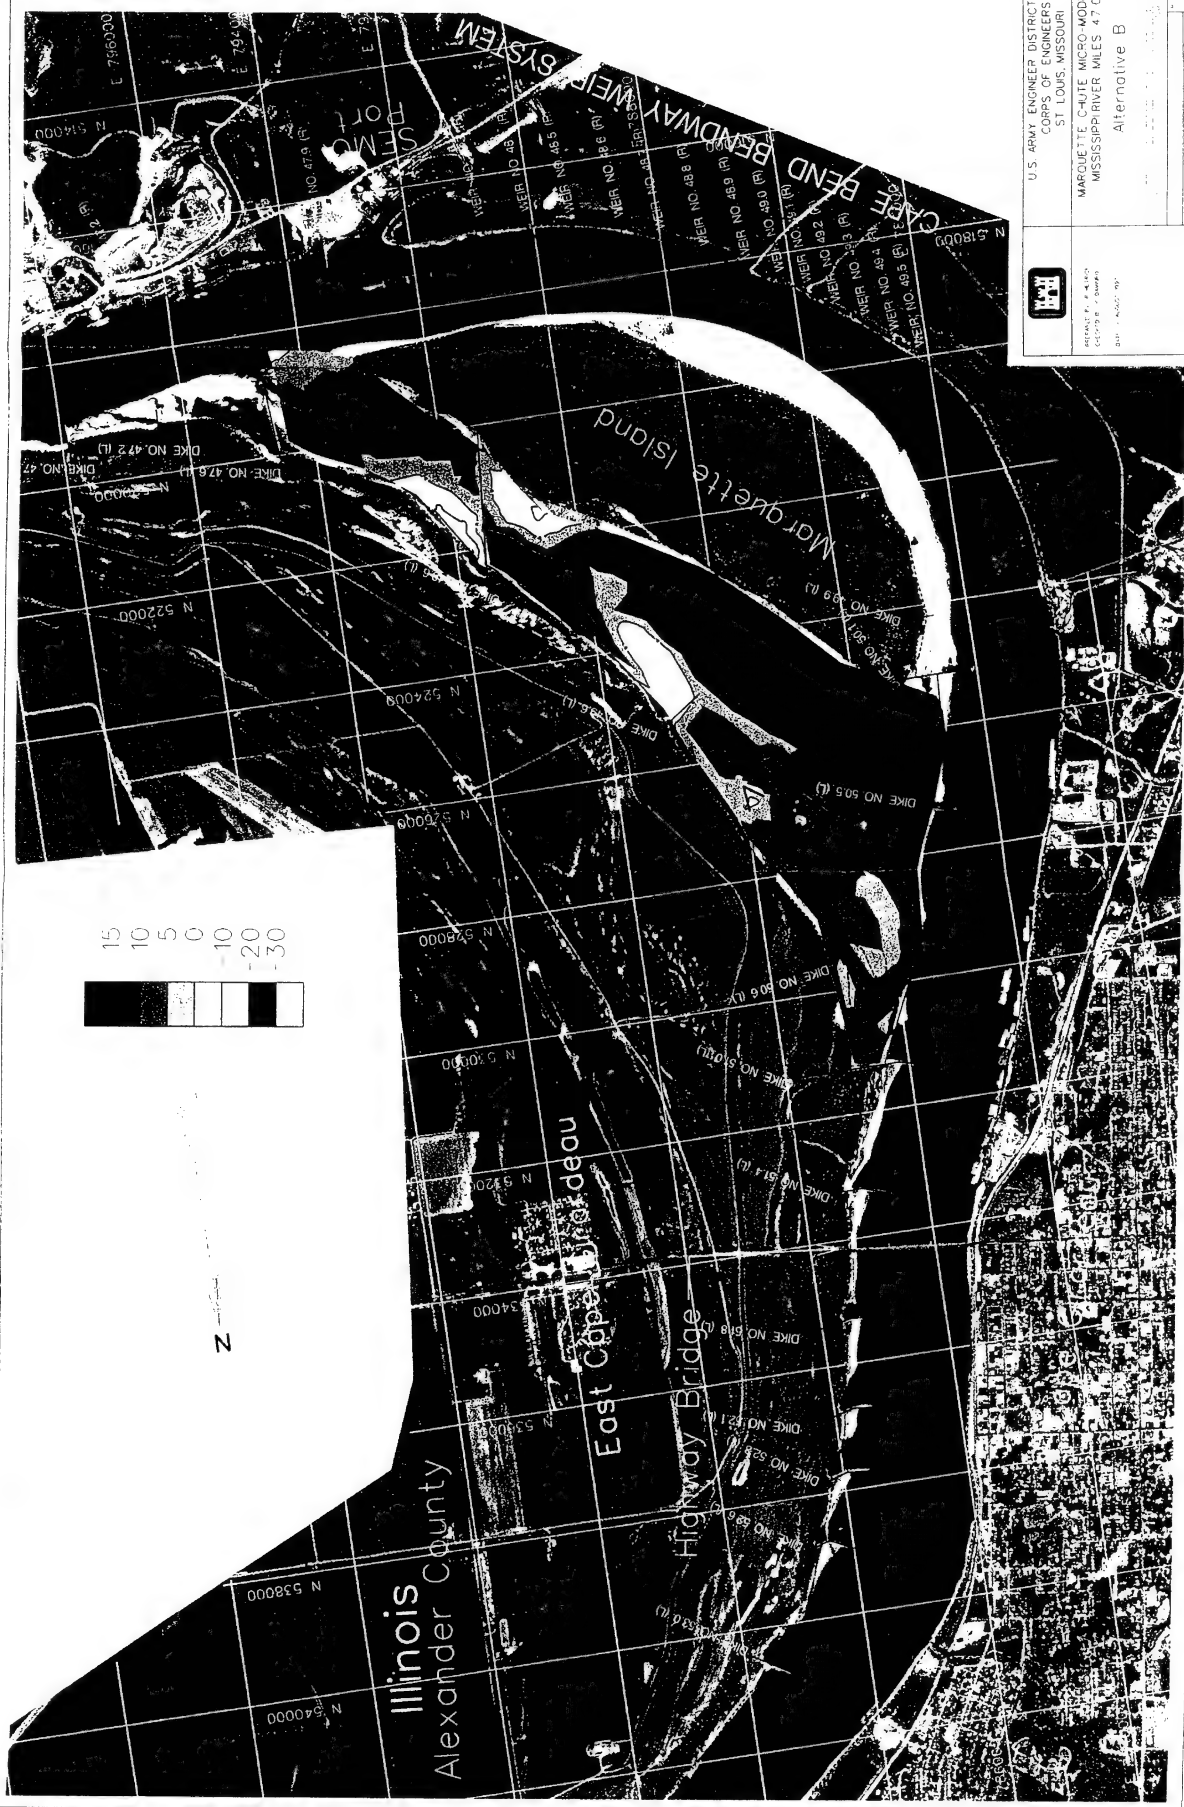
Plate 17 is a plan view contour map of the resultant bed configuration of Alternative B. Results indicated that between Mile 50.6L and Dike 49.6L, an overall deepening of the side channel occurred. Depths increased 5 to 10 feet in this region. Between Dike 49.6L and Dike 47.6L, the channel shallowed 5 to 10 feet. Shallowing was also noticed directly downstream of all river structures, and was observed in the model to be a direct result of the localized displaced sediment lost from the upstream chevron field.

Alternative B

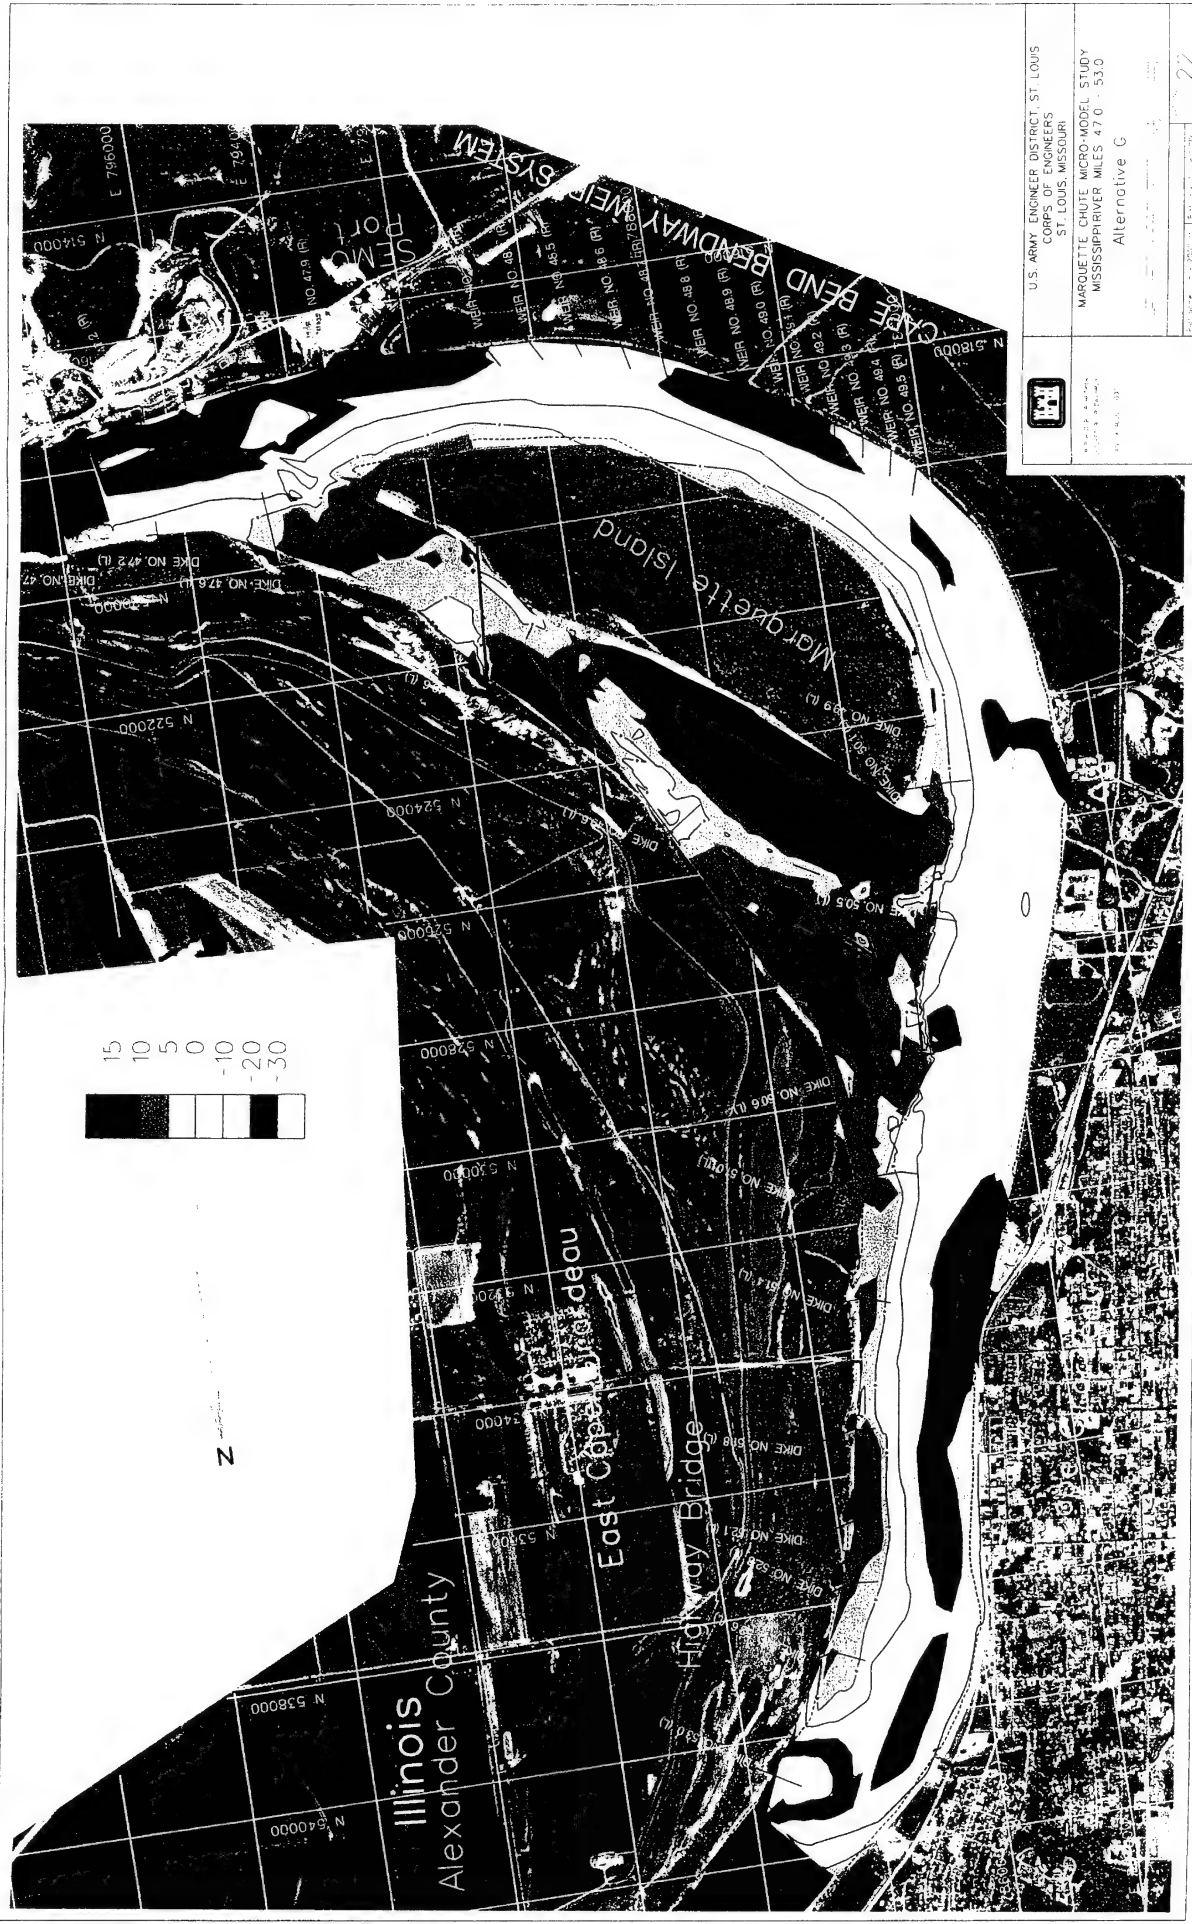
Plate 22 is a plan view contour map of the resultant bed configuration of Alternative G. Results indicated that the lower one half of the side channel had a tendency to shallow. In the upper end of the channel, the scour below the notches was between 10 and 20 feet. A slight deepening (5 to 10 feet) occurred between the upper closure and dike 49.6 L. The adjacent navigation channel remained mostly unchanged.

U.S. ARMY ENGINEER DISTRICT ST. LOUIS CORPS OF ENGINEERS ST. LOUIS, MISSOURI
	MARQUETTE CHUTE MICRO-MODEL STUDY MISSISSIPPI RIVER MILES 47.0 - 53.0 Alternative G
Scale: 1" = 200' (1:200)	
Sheet: 22

- Lowering or removing the lower closure structure in alternatives G, and N, produced minor positive effects throughout the side channel, however, the large scour below the lower closure structure was lost.

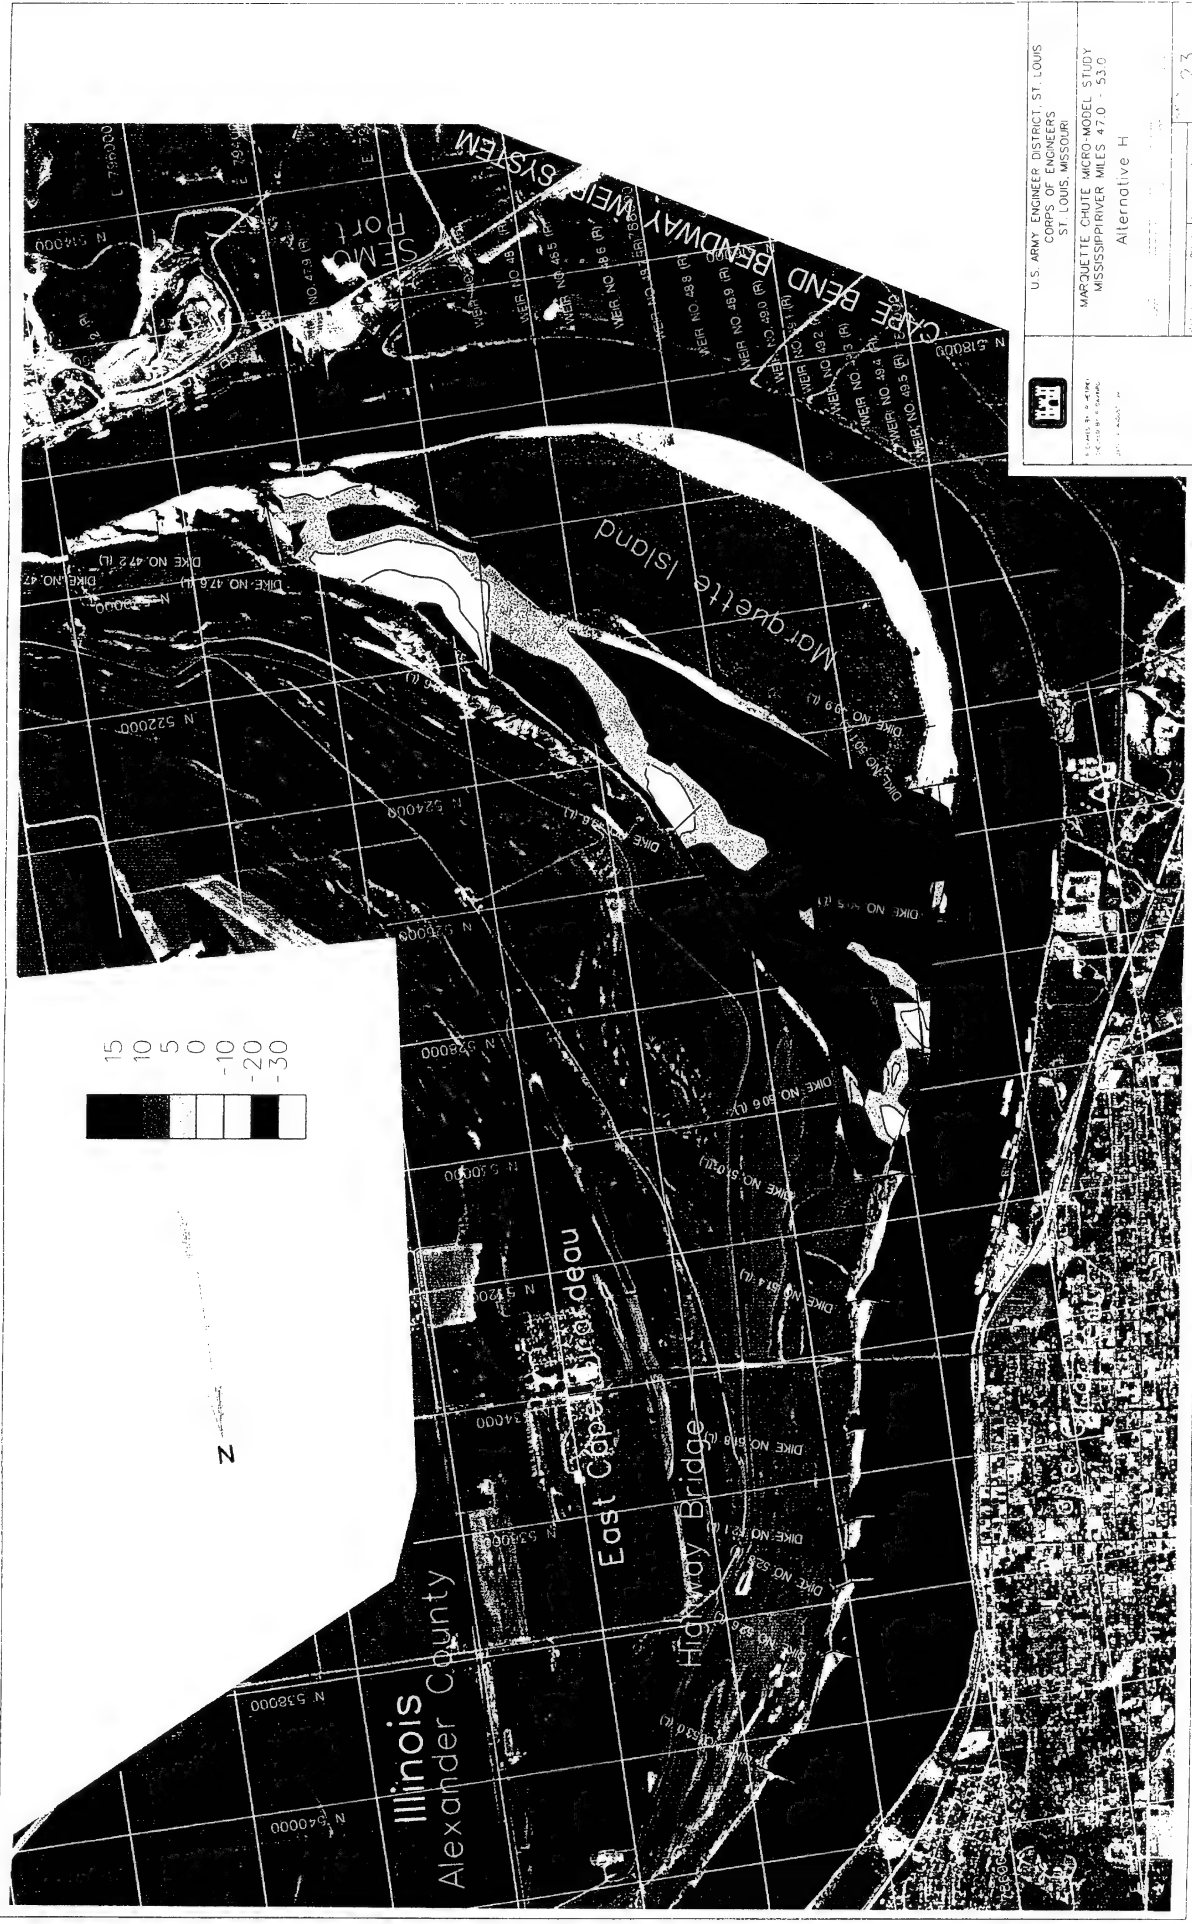
Plate 23 is a plan view contour map of the resultant bed configuration of alternative H. Results indicated that a somewhat deeper channel (5 to 10 feet) developed through the upper half of the side channel. The scour hole at Dike 49.6 shallowed approximately 10 feet.

Alternative H

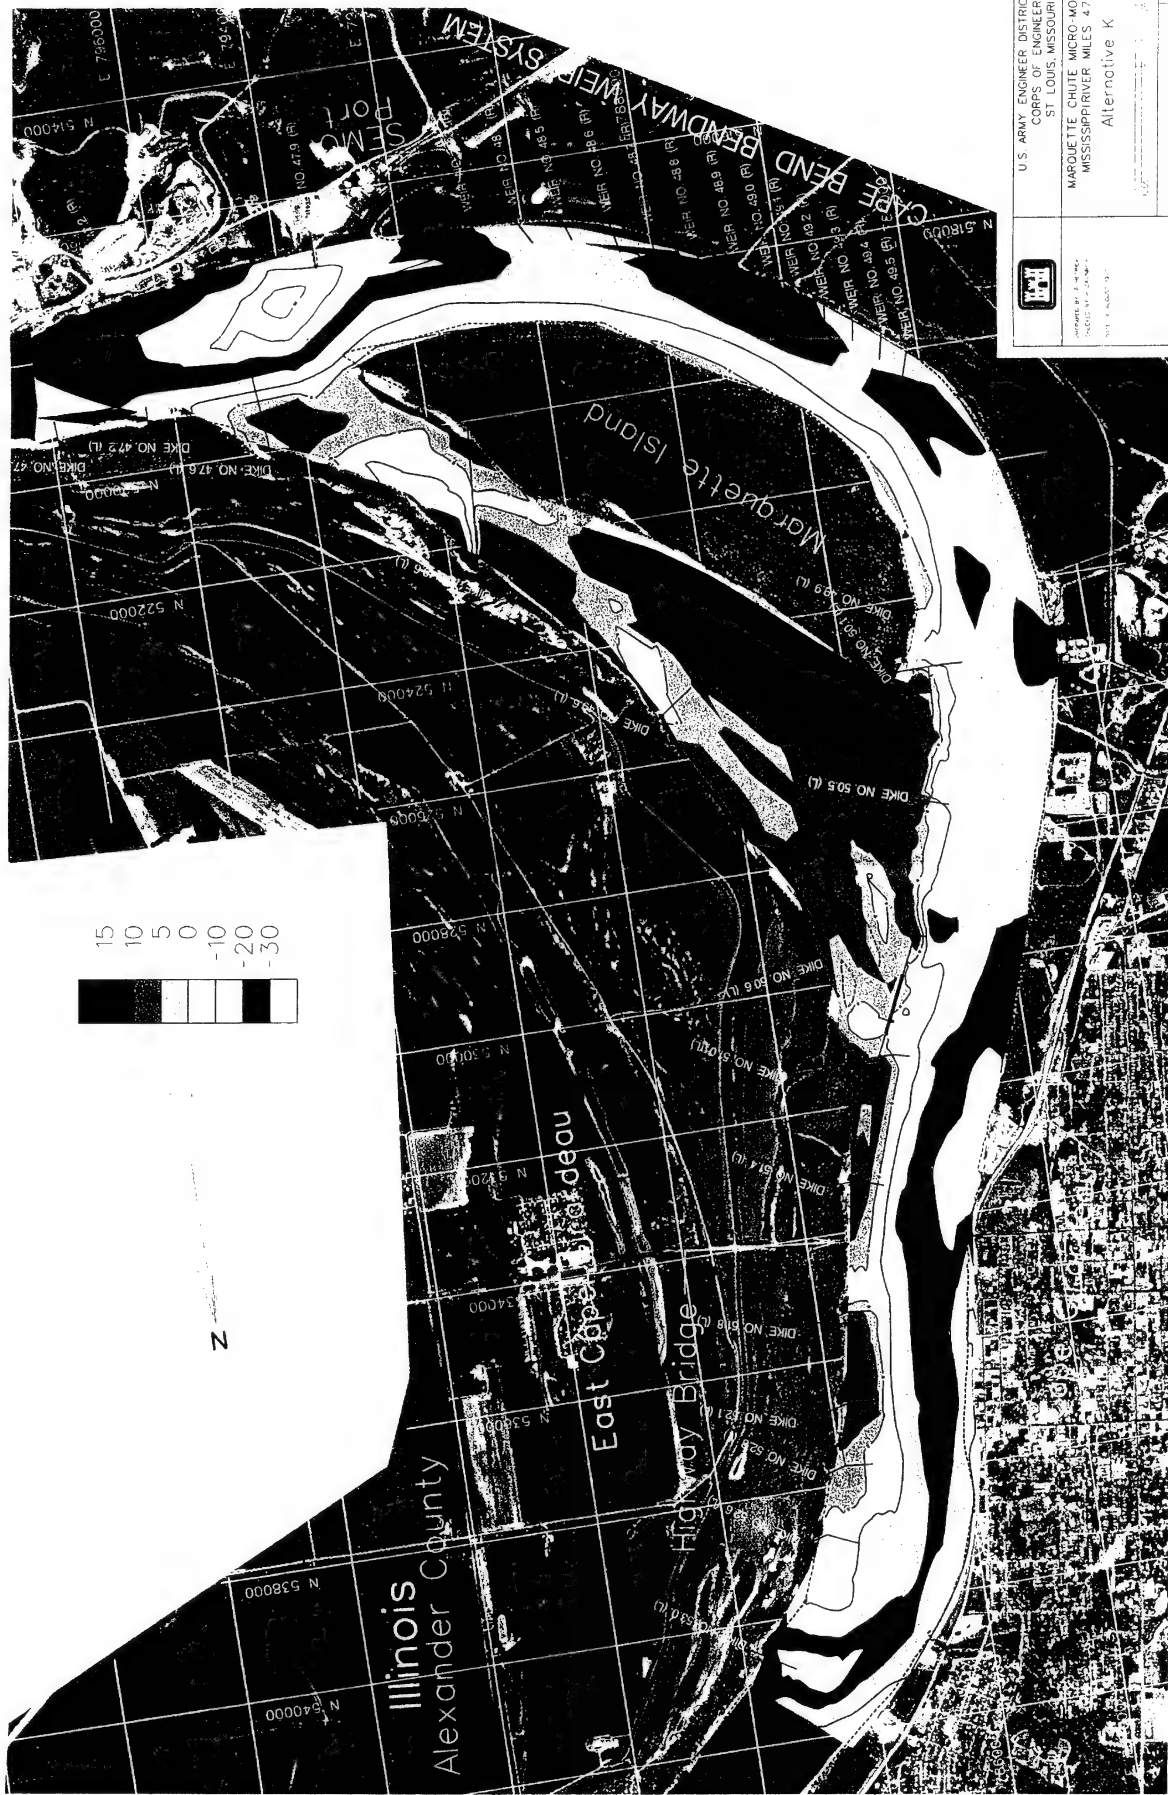
Plate 26 is a plan view contour map of the resultant bed configuration of Alternative K. A large amount of scour was observed throughout the length of the main channel after notching the upper closure structure. Scouring also occurred around the outside of the

bend near Dikes 47.9R and 47.2R. The changes also caused uniform deposition of approximately five feet through most of the side channel. Localized scour was noted around the notched closure structure, as expected.

Alternative K

- In alternatives E, J, and K, the notches in the upper closure structure created deep, localized scour holes without compromising the navigation channel. These notches however, did not significantly enhance habitat throughout the rest of the side channel.
